BUILDING 32 QUARTERMASTER'S STOREHOUSE

Fort Hancock, New Jersey
Sandy Hook Unit, Gateway National Recreation Area

HISTORIC STRUCTURE REPORT

Judith Q. Sullivan

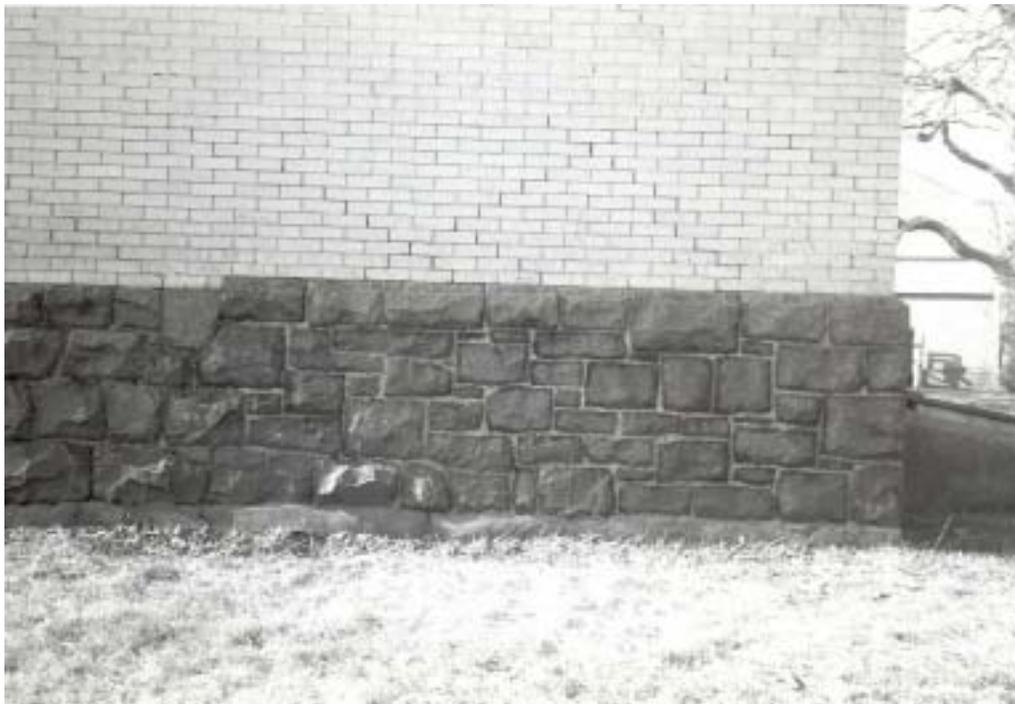
Figure 45. Foundation, north corner of east wall, showing former location of platform [1993].

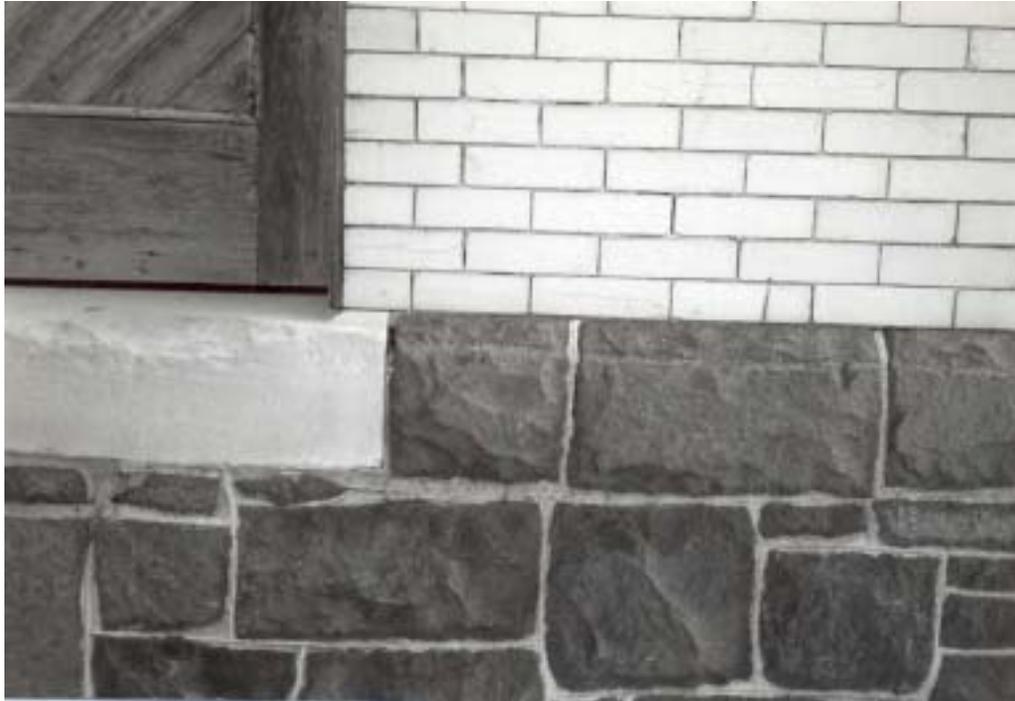
Figure 46. Foundation, east elevation, sill of doorway D-4 inset into foundation [1993].

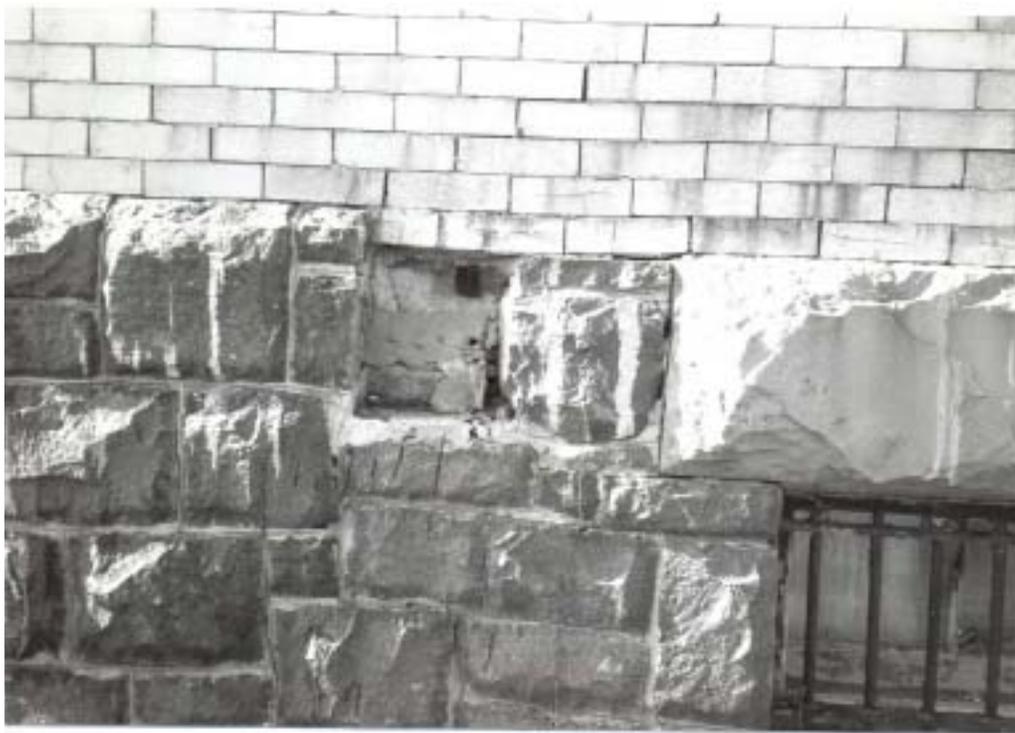
Figure 47. Foundation, west wall, mortise of former platform framing support [1993].

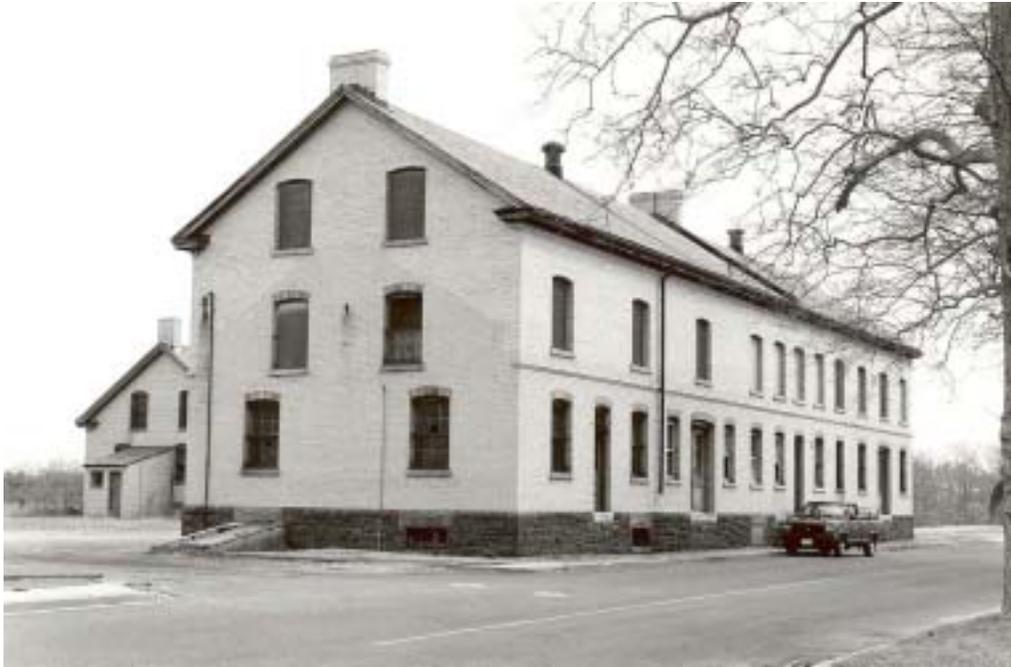
Figure 48. North and west elevations, showing change in brickwork of north gable- end wall [1993].

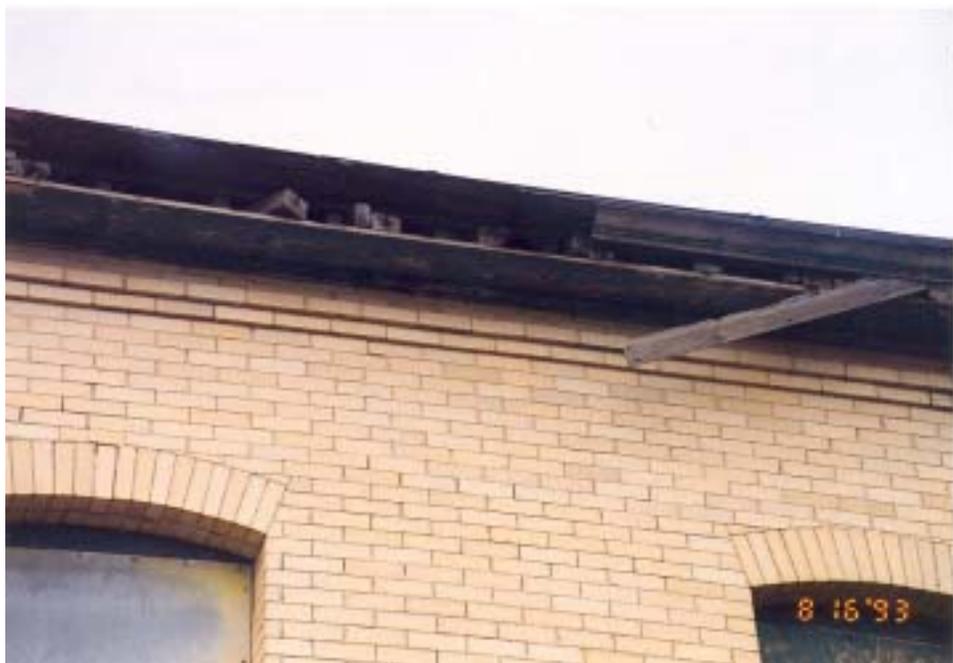
Figure 78. West elevation, deteriorated cornice between windows W 2- 14 and 2- 15 [1993].

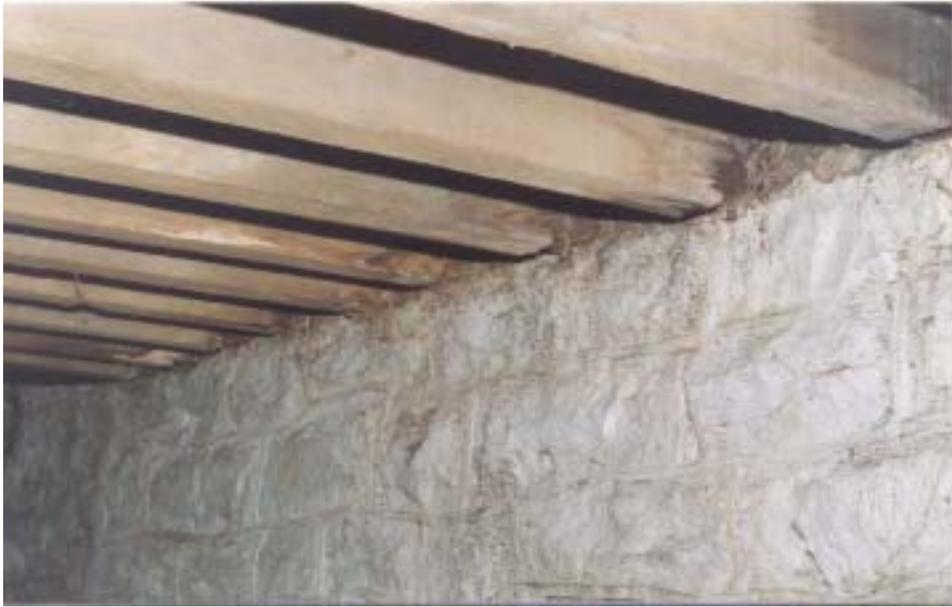
Figure 130. South part of basement: first- floor joists fire- cut and set into east foundation wall [1993].

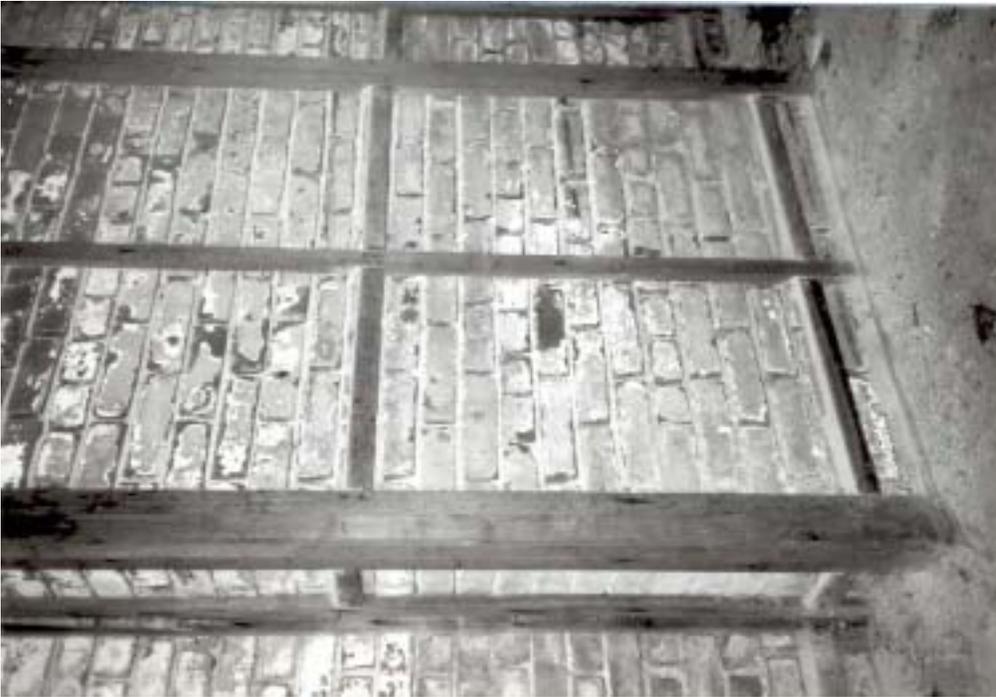
Figure 144. Room 110, south wall: projecting chimney breast with furring strips for former plywood sheathing [1993].
